# access to the environment

Case Studies of Barrier Free Sites

Volume 2

**A Series of Reference Documents on the Design and  
Development of Site Facilities to Make Them  
Barrier Free to the Physically Handicapped and Disabled**

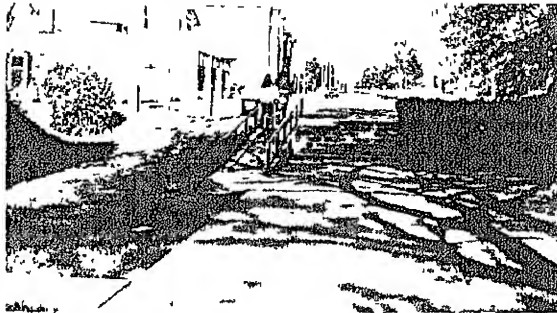
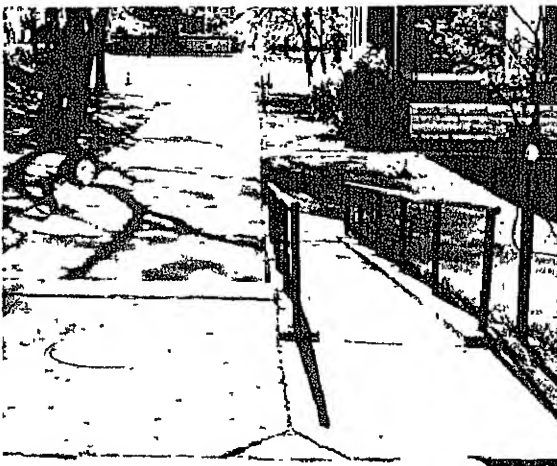
Curb cuts or curb alterations have been made throughout the campus. Essentially two forms of curb cut have been used. One is a straight curb cut with ramping, the other is an offset dropped curb and ramp. Photographs show several varieties.

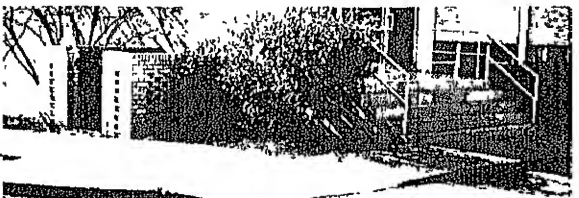
Sidewalks and other pathways throughout the campus have been made passable for the handicapped. Permanent ramps may be either integral or additive, temporary ramps may be stationary or portable.

It should be noted that the ramps have made all pathways easier to traverse by bicycle. This has both positive and negative aspects - while serving a large number of students, a conflict is created between the various wheeled vehicles - the slow wheelchair and the much faster bicycle.
